**L.I.S. DEVELOPMENT FOR THE REGISTRATION AND CLASSIFICATION
OF THE 1999 ATHENS EARTHQUAKE DAMAGES.
APPLICATION ON THRAKOMACEDONES COMMUNITY.**

Alkistis Iliadi,	Surveyor Engineer
Androniki Xidia,	Surveyor Engineer
Anastassios Labropoulos,	Ph.D.Student N.T.U.A.
Panagiotis Zentelis,	Civil & Surveyor Engineer, Ass.Professor N.T.U.A.

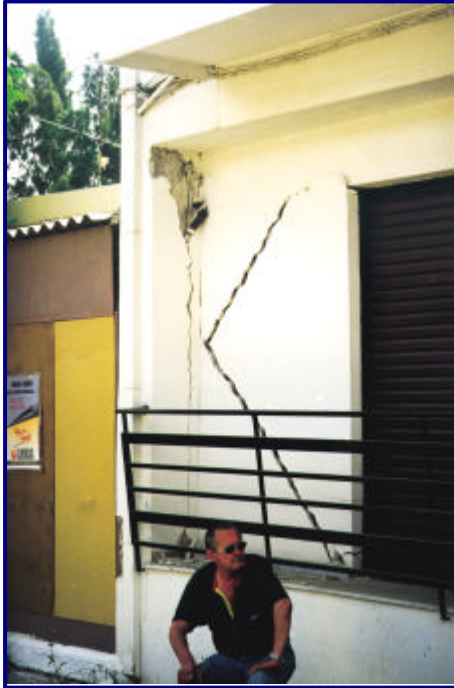
1^a. Disconnection of an infill brickwall from the load bearing system.

1^b. Shear cracking of an infill brickwall.

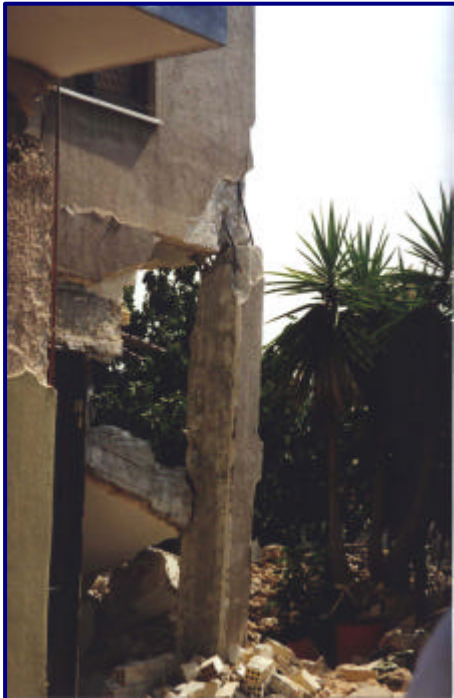
5^a. Overloading of a corner column due to seismic action. The lack of adequate stirrups is evident.

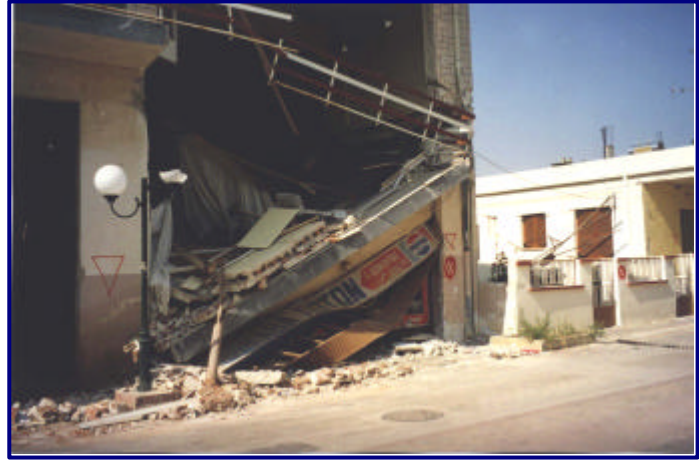
2. Collapse of a reinforced concrete slab due to yielding of a reinforced concrete column

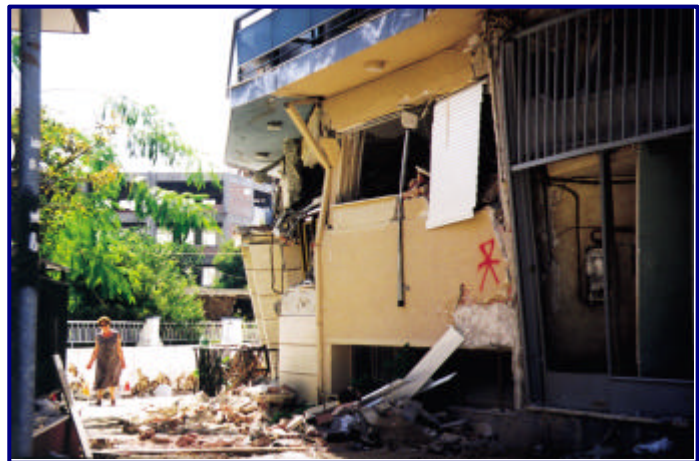
3. Fracture of a beam at the perimeter of the load bearing system, close to its corner

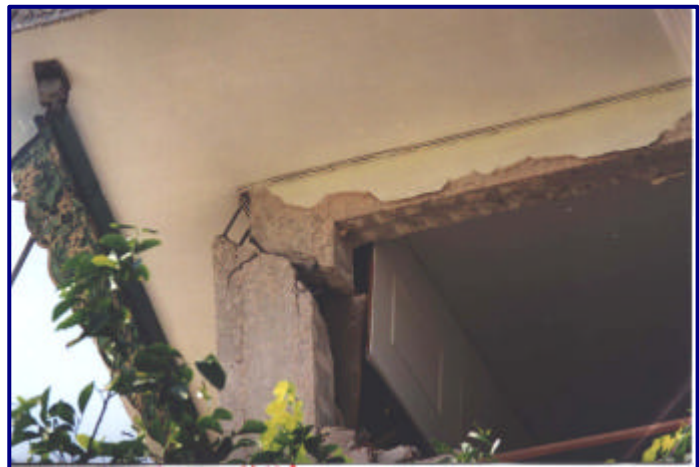
4. Disorganization of a beam to column joint

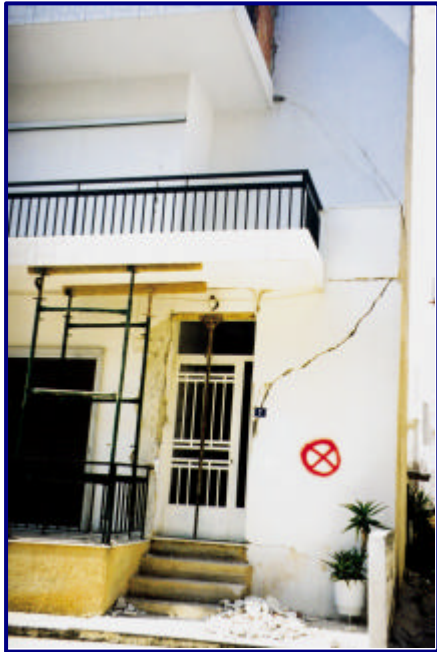
5^b. Cracking of shear wall at the corner of the building

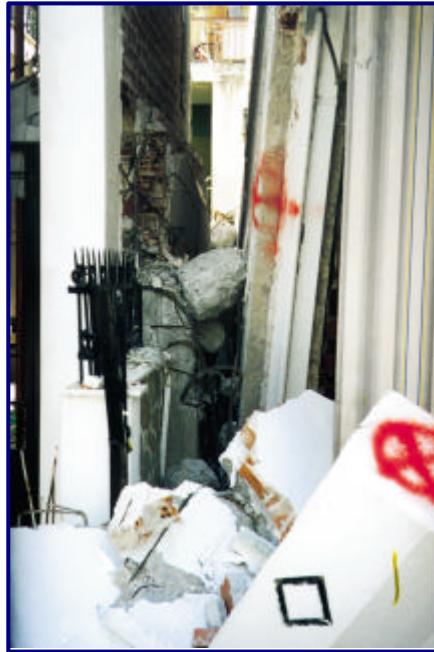
5^c. Inclination of a shear wall due to lack of stiffness in the perpendicular direction to its surface

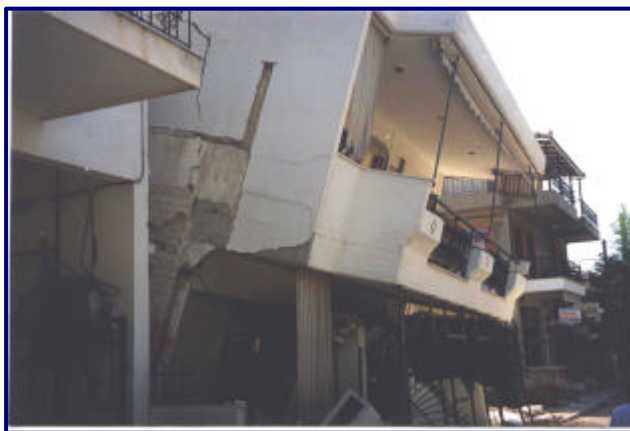
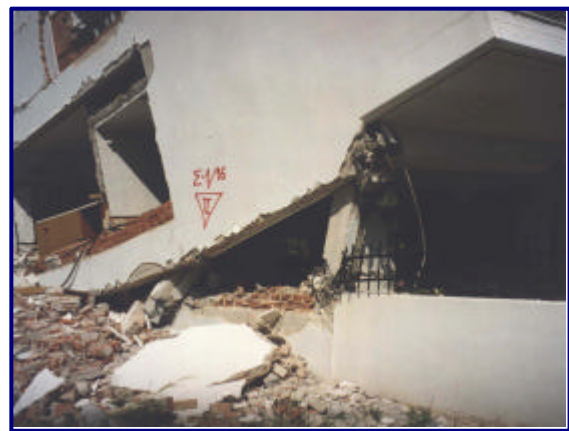
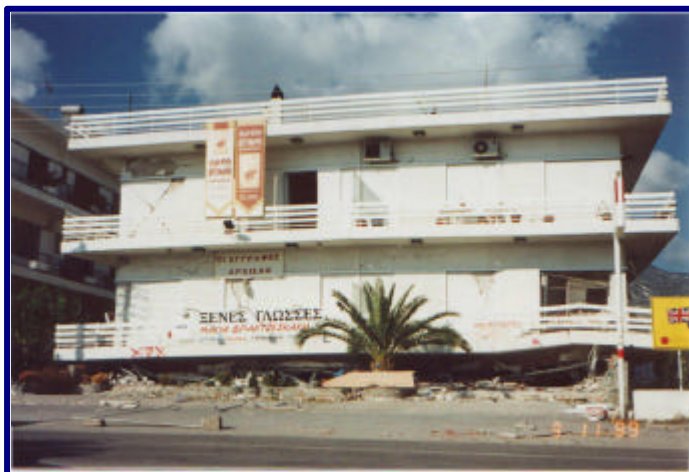
6. Collapse due to failure of columns at the soft ground floor

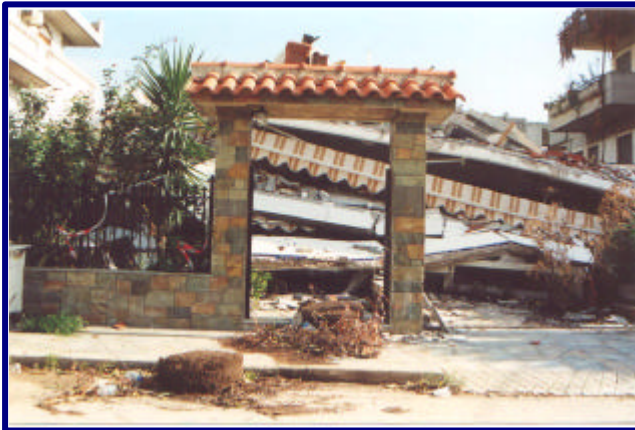
7^a. Collapse due to total failure of columns

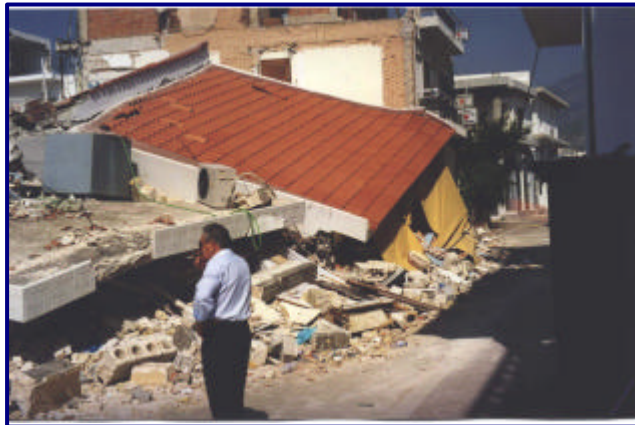
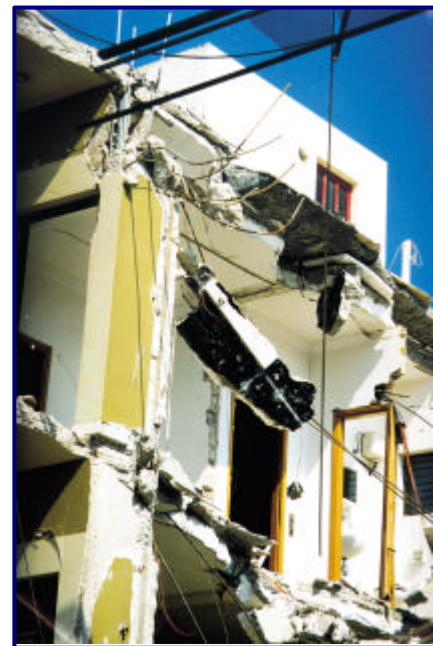
7^b. Partial collapse of the load bearing system

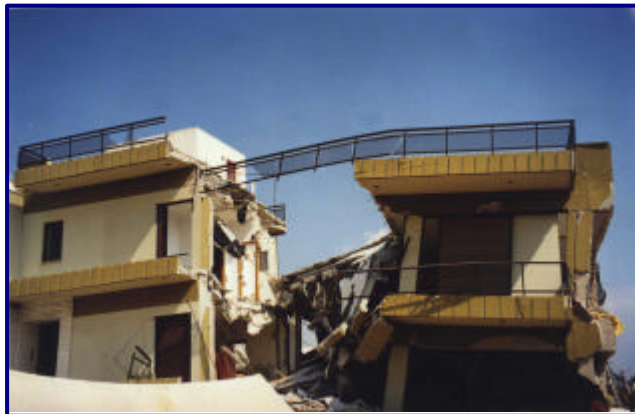
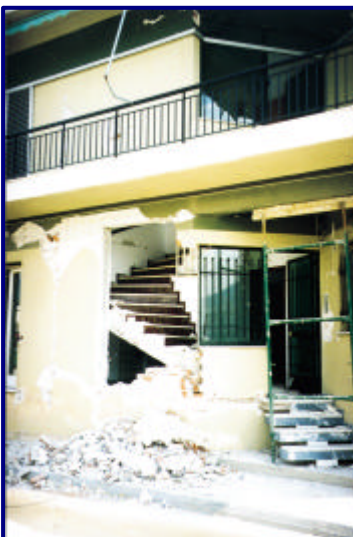
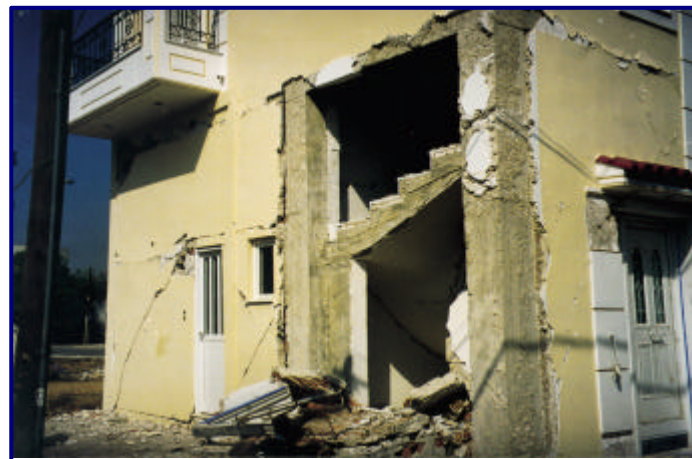
8. Absorption of seismic energy at the region where there is concentration of large mass of reinforced concrete
