FIG WORKING WEEK 2012  
May 6-10 2012  
Rome, Italy

**A STUDY ON THE ASSESSMENT OF BATHYMETRIC  
CHANGES VIA GIS: ALTINAPA DAM (KONYA) EXAMPLE**

**Asist. Prof. Dr. Ayhan CEYLAN**  
aceylan@selcuk.edu.tr  
**Eng. Ilke Ekizoglu**  
ilk\_er28@hotmail.com

Selcuk University  
Faculty Of Engineering & Architecture, Department of Geomatic Engineering

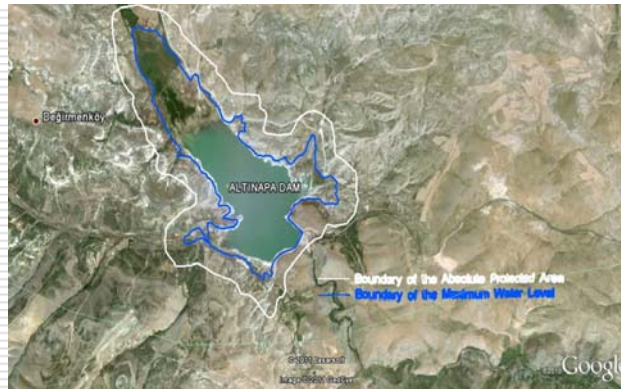
General View of Altınapa reservoir

Altınapa Reservoir is 20 km from the western part of Konya province . Altınapa Dam is a rock-fill dam built for potable water, flood control and irrigation, which has been operational since 1967.

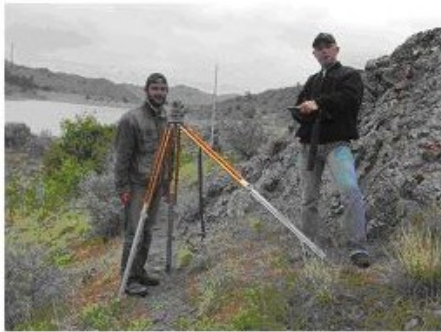
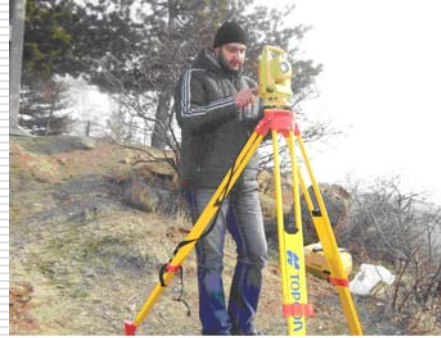
Topographical measurements were made using Topcon Precision GPS Hyperpro GPS receivers (RTK-GPS) and Topcon GPT 3007 electronic tachymeter.

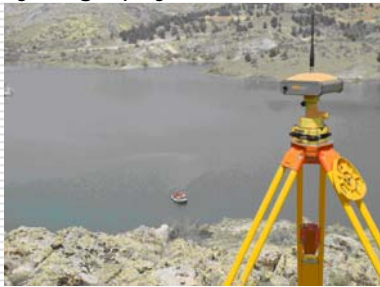
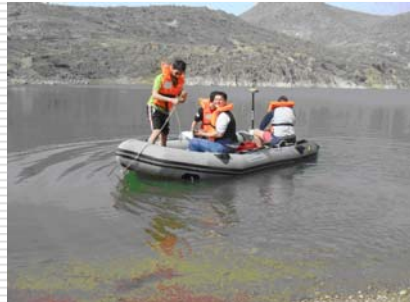
Horizontal location information of the depth measurement points was acquired by an RTK-GPS with Topcon Precision GPS Hyperpro receiver. One of the GPS receivers was established on reference point while the other was mobile and used on the hydrography boat.

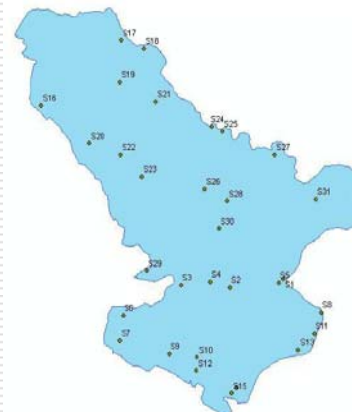
Water quality measurements were conducted in conjunction with bathymetric measurements. Samples from 31 locations gave pH, turbidity, dissolved oxygen and temperature values of water. A WTW 340i multi-parameter device and a 30 cm diameter Secchi disc were used in measurements.

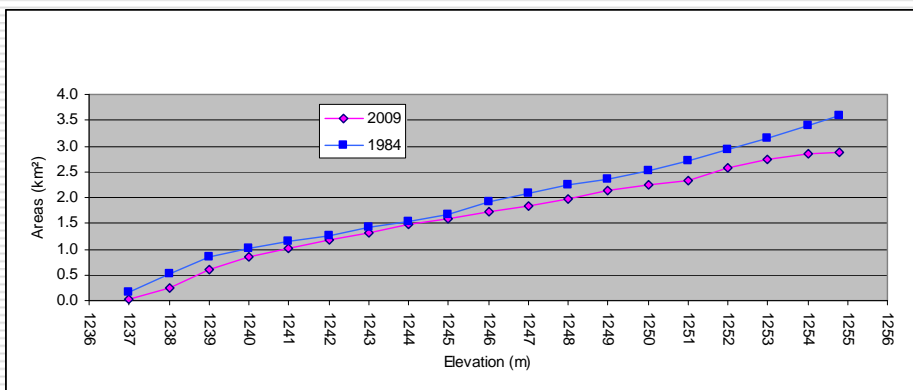
## The surface areas at various water elevations

Surface areas at various water elevations are shown in Figure

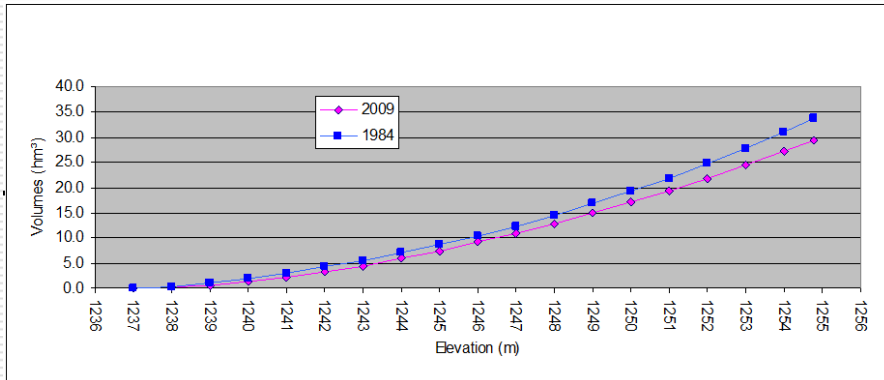
## The volumes at various water elevations

Volumes at various water elevations are shown in Figure

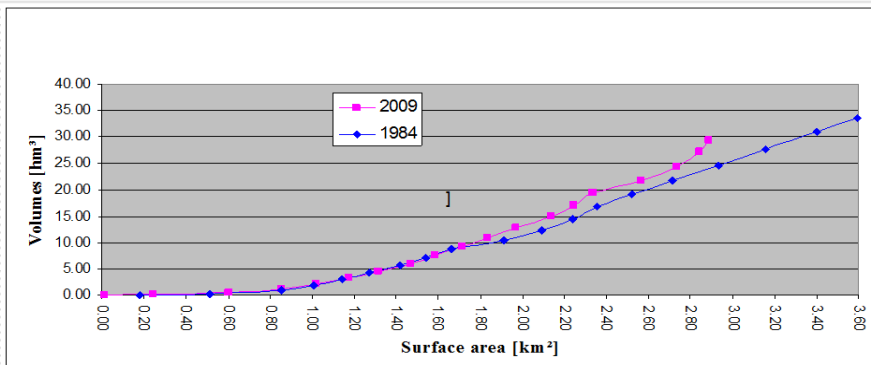
## The surface areas versus volumes

Surface areas versus Volumes are shown in Figure
