# 2,975 Hurricane Maria: The Role of Land Surveyors in Infrastructure Resiliency

Ruth TRUJILLO and Víctor SEDA, Puerto Rico

**Key words:** Hurricane Maria, Puerto Rico, Land Surveyor, Resiliency, Geospatial Data, Precise Measurement, Natural Disaster, Critical Infrastructure

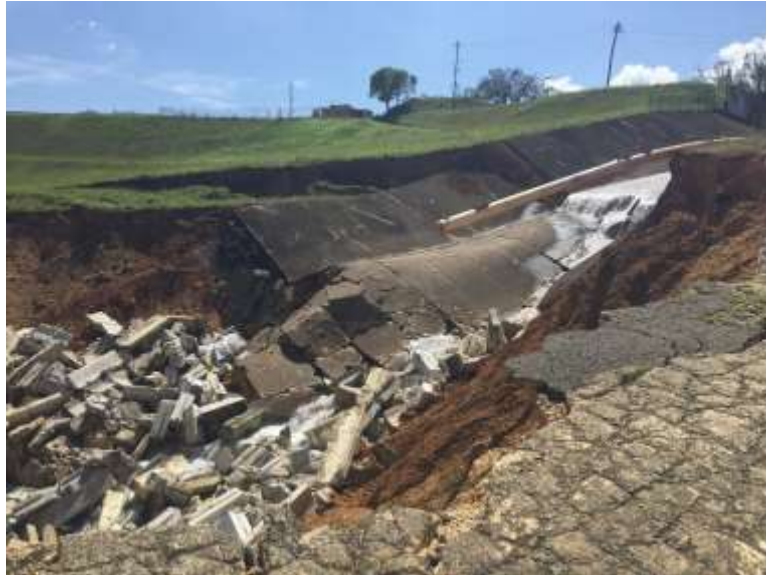
The heavy rainfall of hurricane Maria caused the lake's levels to exceed the flood limit, crossing over state highway PR-119, and, as consequence, having access to the spillway located west of the dam. The combination between the accumulation of water having access to the spillway and the curve that the course of the water should take, caused what is identified in engineering as a hydraulic leap.

This hydraulic leap caused the water to jump, falling into the spillway and causing the collapse and fracture of this structure. There was also a fault in the gate that gave way to the 54" pipe from the tunnel that crosses under the dam and the gate that feeds the river through a 96" pipe.

*Figure 4. Erosion at base of dam. (Seda, 2017)*

As soon as the Puerto Rico Power Authority acknowledge the damage, mitigation efforts began to avoid the erosion of the land in the western part of the dam. With help from the US Army Corps of Engineers' personnel, New Jersey-type concrete barriers and sandbags were arranged in the lower part of the spillway, creating a dissipator in which the levels of the lake were lowered, and flow was completely controlled. Rip rap and gabion stone were also deposited on the entire surface.

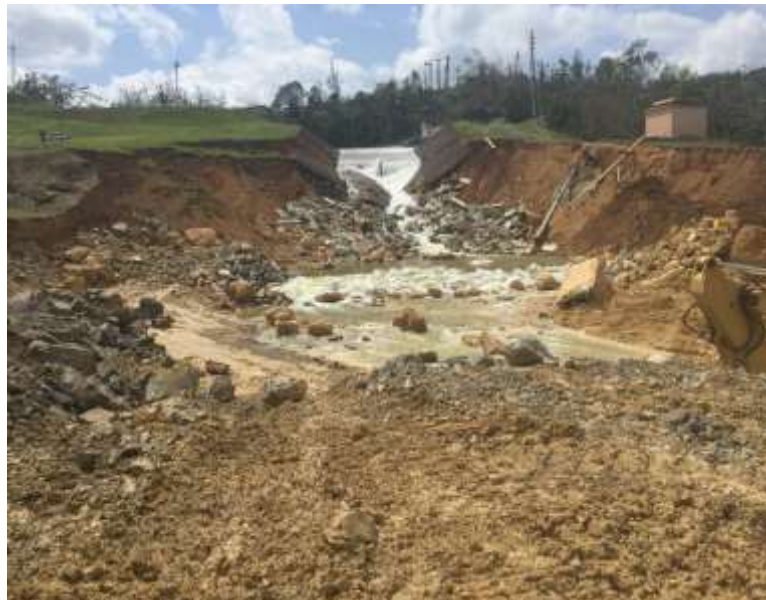
Another damage caused by this catastrophic storm was the collapse of a 54" reduced to 48" concrete pipe siphon, which fed the diversion channel that carries the water to municipalities served by the dam.

*Figure 5. Erosion at base of dam. (Seda, 2017)*

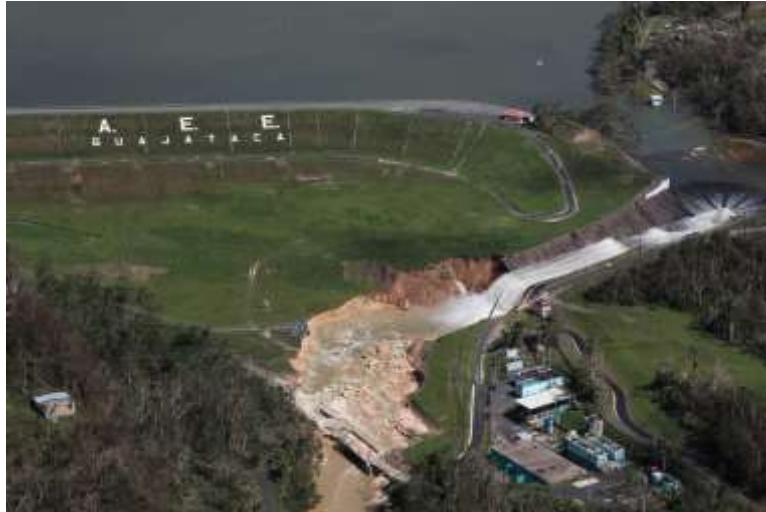
Emergency warnings were issued informing pertinent authorities of this situation. The National Meteorological Service issued a Notice of Failure in the dam. This situation caused thousands of people to be without drinking water service with their lives at risk due to this collapse. 70,000 people were evacuated from their residences as a preventive measure.

*Figure 6. Aerial view showing the damage to the Guajataca Dam in the aftermath of Hurricane Maria. (Alvin Baez/ Reuters, 2017)*

The US Army Corps of Engineers is working on a design to avoid events like this in the future. They are currently working on the construction and connection of a new siphon below the spillway to feed the diversion channel. The construction of a spillway in the center of the dam and the restoration of the existing one is projected as a next phase of the mitigation plan.

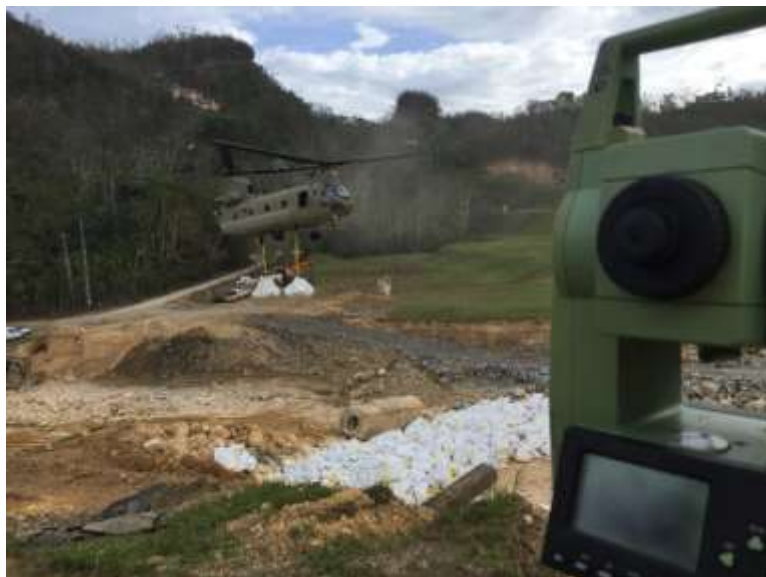
*Figure 7. US Army Corps of Engineers' personnel collaborating in the mitigation efforts at Guajataca Dam after hurricane Maria. (Seda, 2017)*

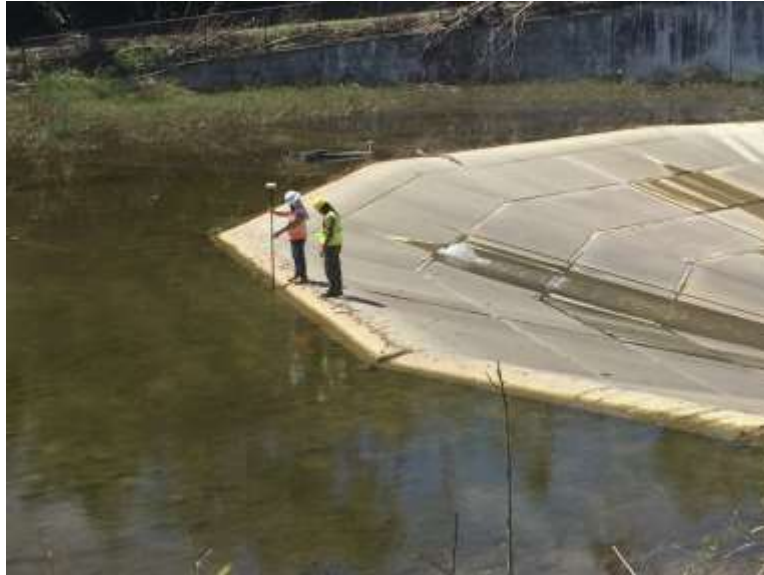
The National Geodetic Survey (NGS) Coordinate Conversion and Transformation Tool (NCAT) application was used to transform data collected with the VRS under the North American Datum (NAD83) epoch 2010 revision 2011 to NAD83 (FBN1997).

*Figure 10. Land Surveyors perform As-built Survey applying Real-Time Kinematic (RTK) techniques at Guajataca Dam after hurricane Maria. (Seda, 2017)*
